Asset Management Plan

2023

OC San owns and operates wastewater collection system infrastructure, as well as two resource recovery and wastewater treatment facilities located in Fountain Valley and Huntington Beach. Our collection system infrastructure includes 388 miles of regional trunk sewer pipelines and 15 pump stations throughout the OC San service area (Figure ES-1-1). Wastewater is conveyed to Reclamation Plant Number (No.) 1 in Fountain Valley and Treatment Plant No. 2 in Huntington Beach. These facilities treat an average daily wastewater flow of 185 million gallons per day, serving over 2.6 million people in central and northern Orange County, California.

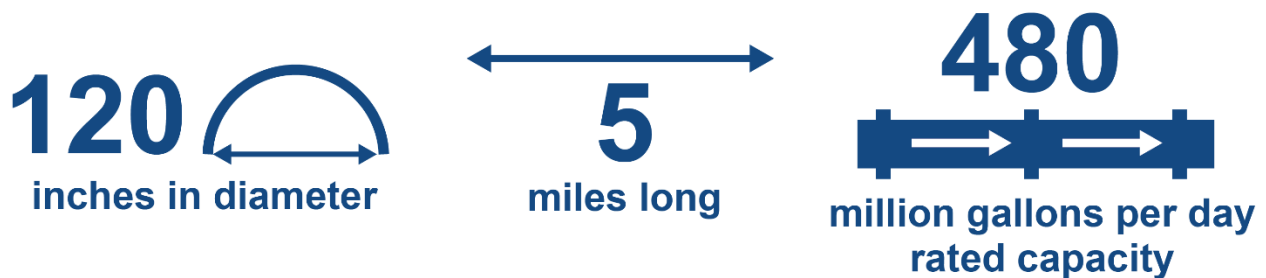
OUTFALL NO. 2 PRIMARY OCEAN OUTFALL

Outfall No. 2 serves as the primary ocean outfall, discharging treated wastewater approximately 5 miles offshore at a depth of approximately 200 feet. It began service in 1971. A comprehensive assessment was completed and based on the findings a rehabilitation project is in progress to ensure the outfall's reliability for many years to come.

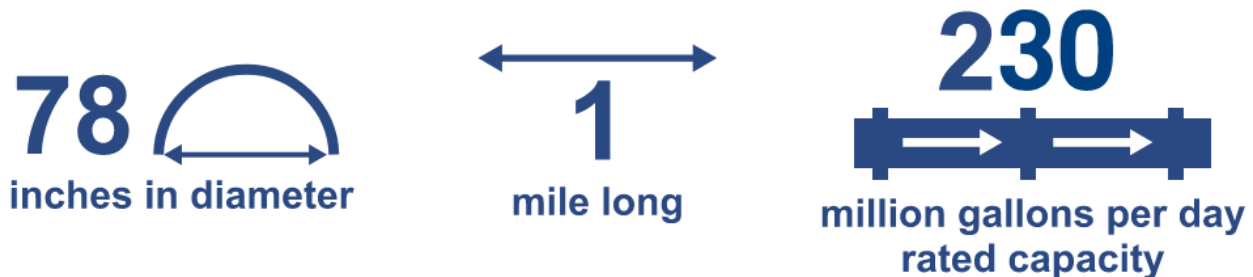
OUTFALL NO. 1 EMERGENCY OUTFALL

Outfall No. 1 serves as an emergency outfall and primary backup to Outfall No. 2, discharging treated wastewater over a mile offshore at a depth of approximately 65 feet. It was originally constructed in 1954 and was later modified in 1965. Outfall No. 1 serves as a primary backup to Outfall No. 2. OC San's NPDES permit specifies that this outfall can be used only in the case of an emergency or during planned maintenance activities. This outfall will also go through a comprehensive assessment in the near future.

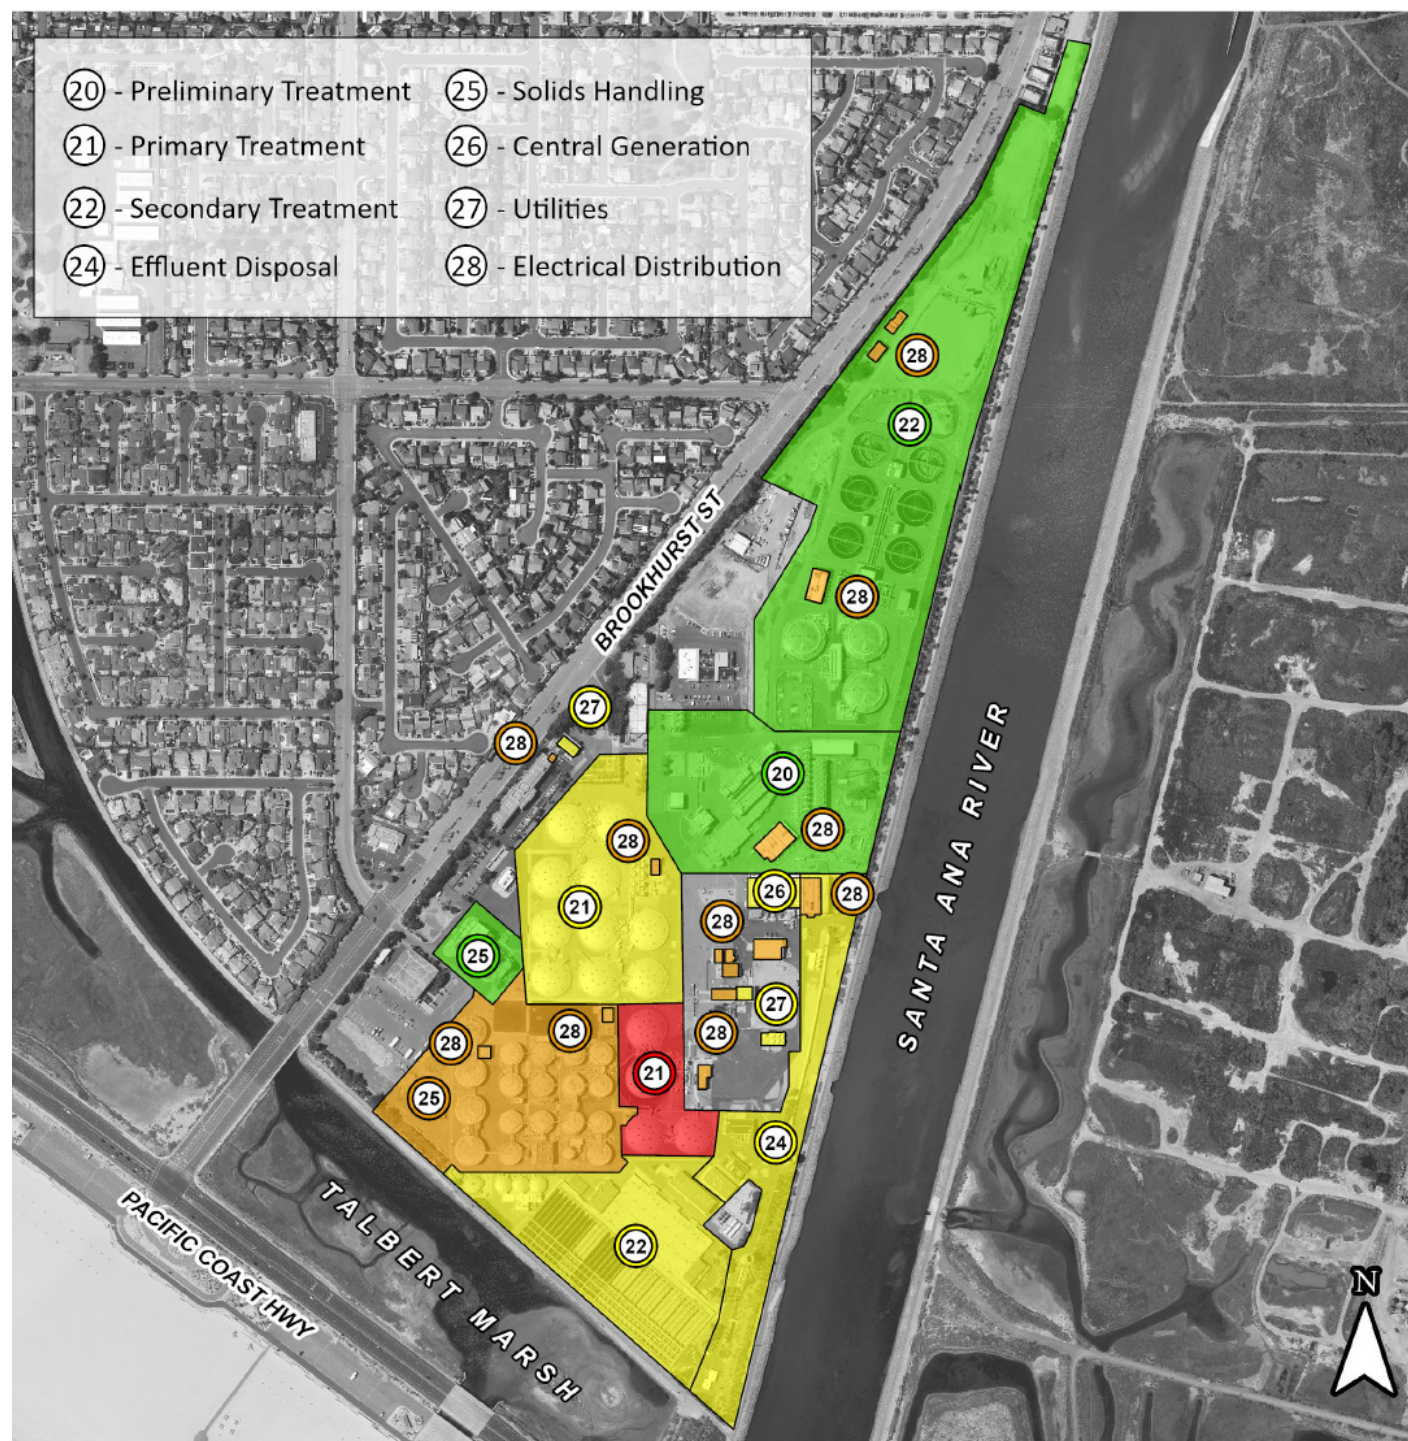
Figure 2-2. Plant No. 2 Process Area – Remaining Useful Life Score Map

The system-level summaries include an area map (Figures 2-1 through 2-4) showing the general layout of the process areas or collection system, and a table (Tables 2-1 through 2-4) with the following fields:

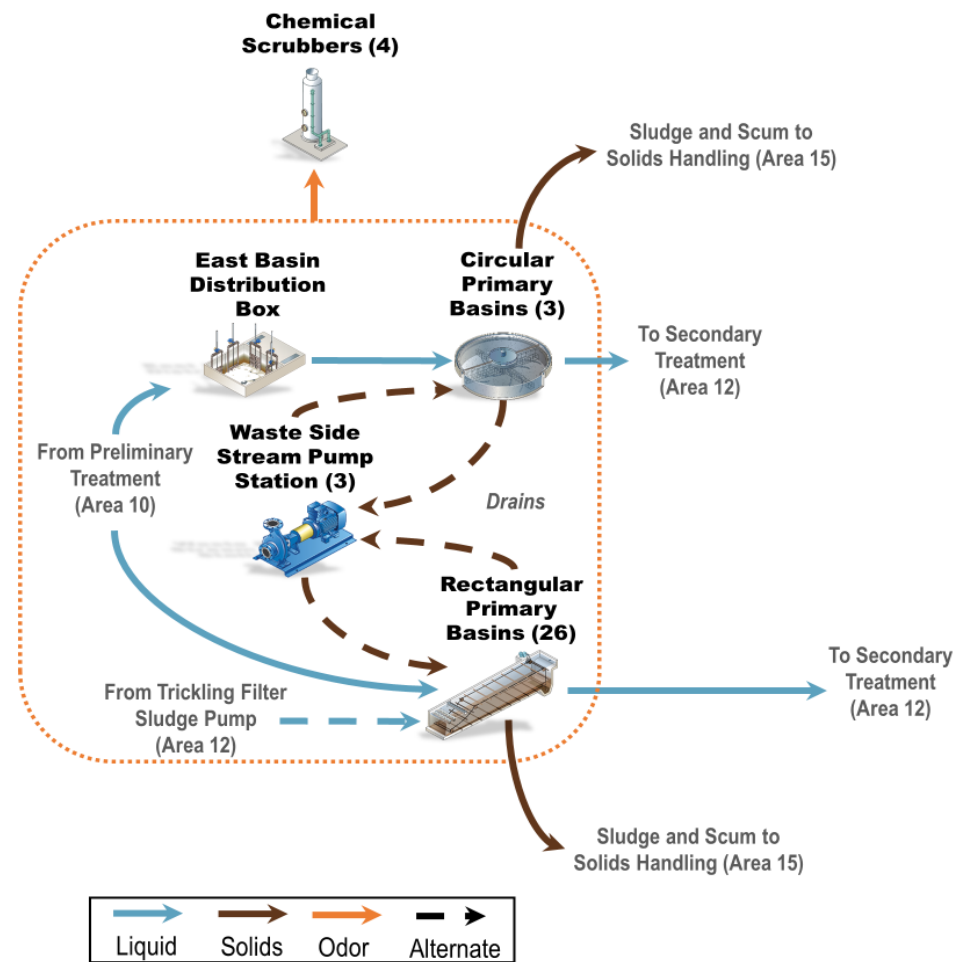
Process Schematic

Note: Primary Basins No. 1 and No. 2 are not shown. The facilities are available for emergency capacity during high flows and are scheduled to be demolished within the next 10 years.

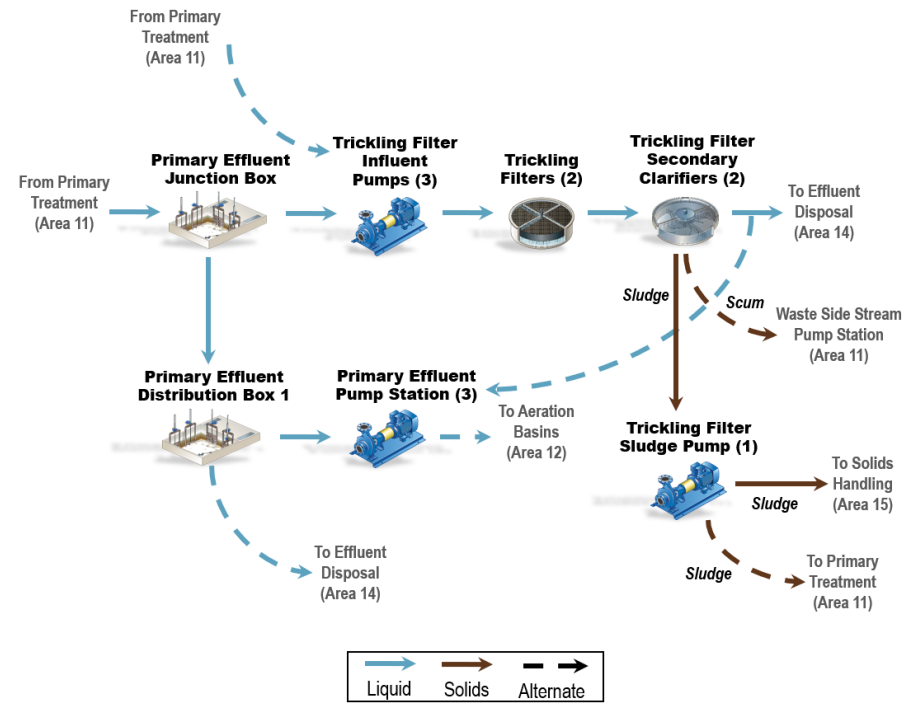
Process Schematic

ASSET MANAGEMENT SYSTEM SUMMARY – AREA 12 – PLANT NO. 1 SECONDARY TREATMENT – TRICKLING FILTERS

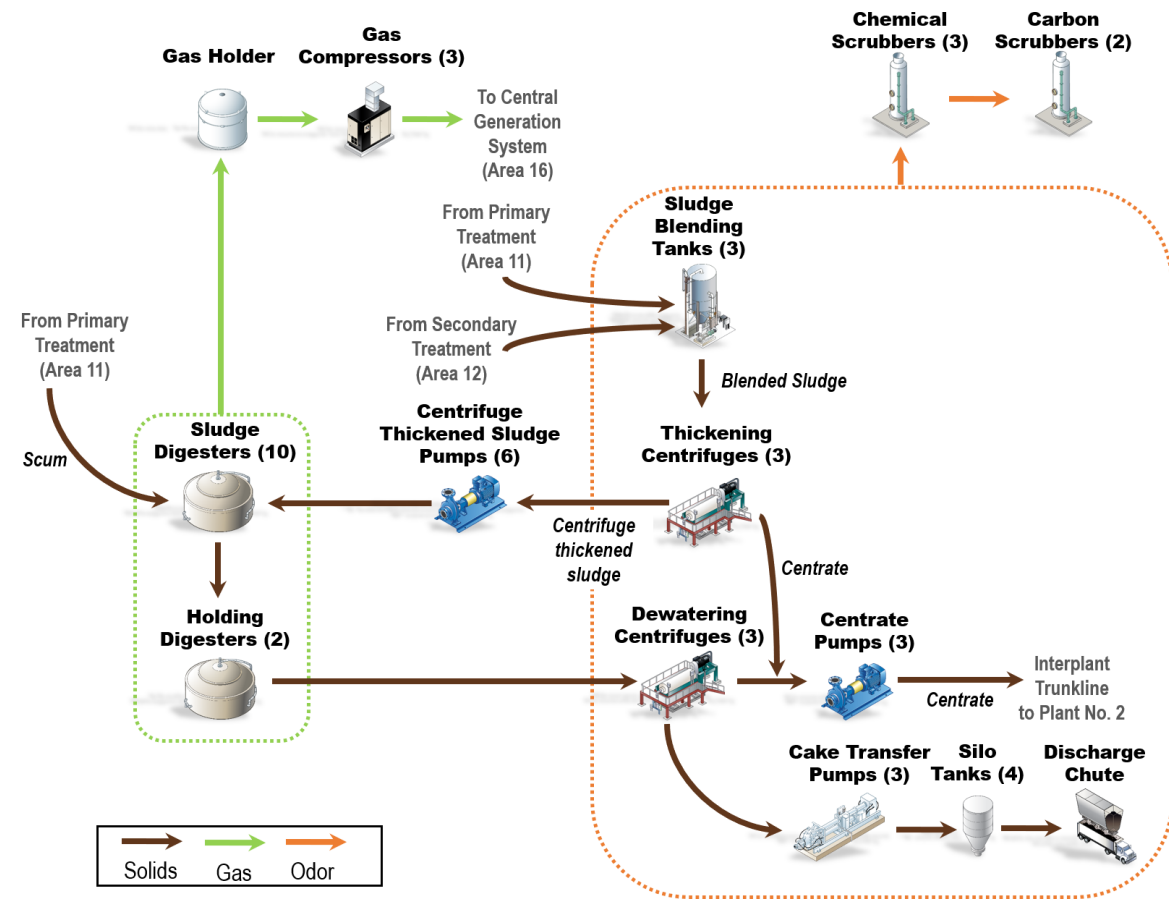
Process Schematic

ASSET MANAGEMENT SYSTEM SUMMARY – AREA 15 – PLANT NO. 1 SOLIDS HANDLING – DIGESTERS

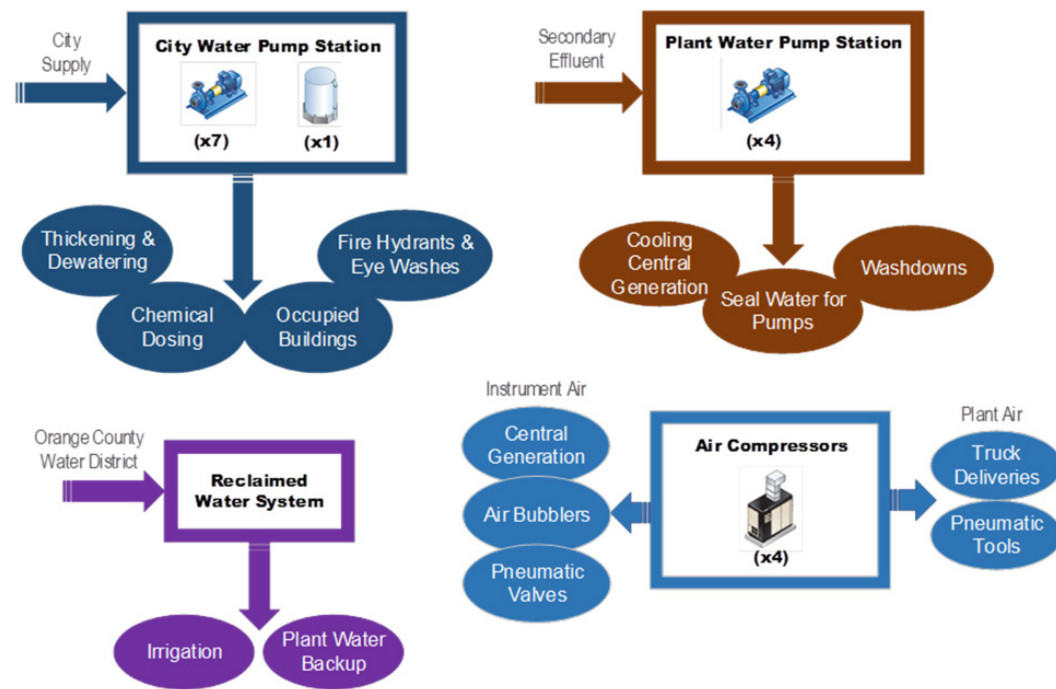
Process Schematic

ASSET MANAGEMENT SYSTEM SUMMARY – AREA 17 – PLANT NO. 1 UTILITIES

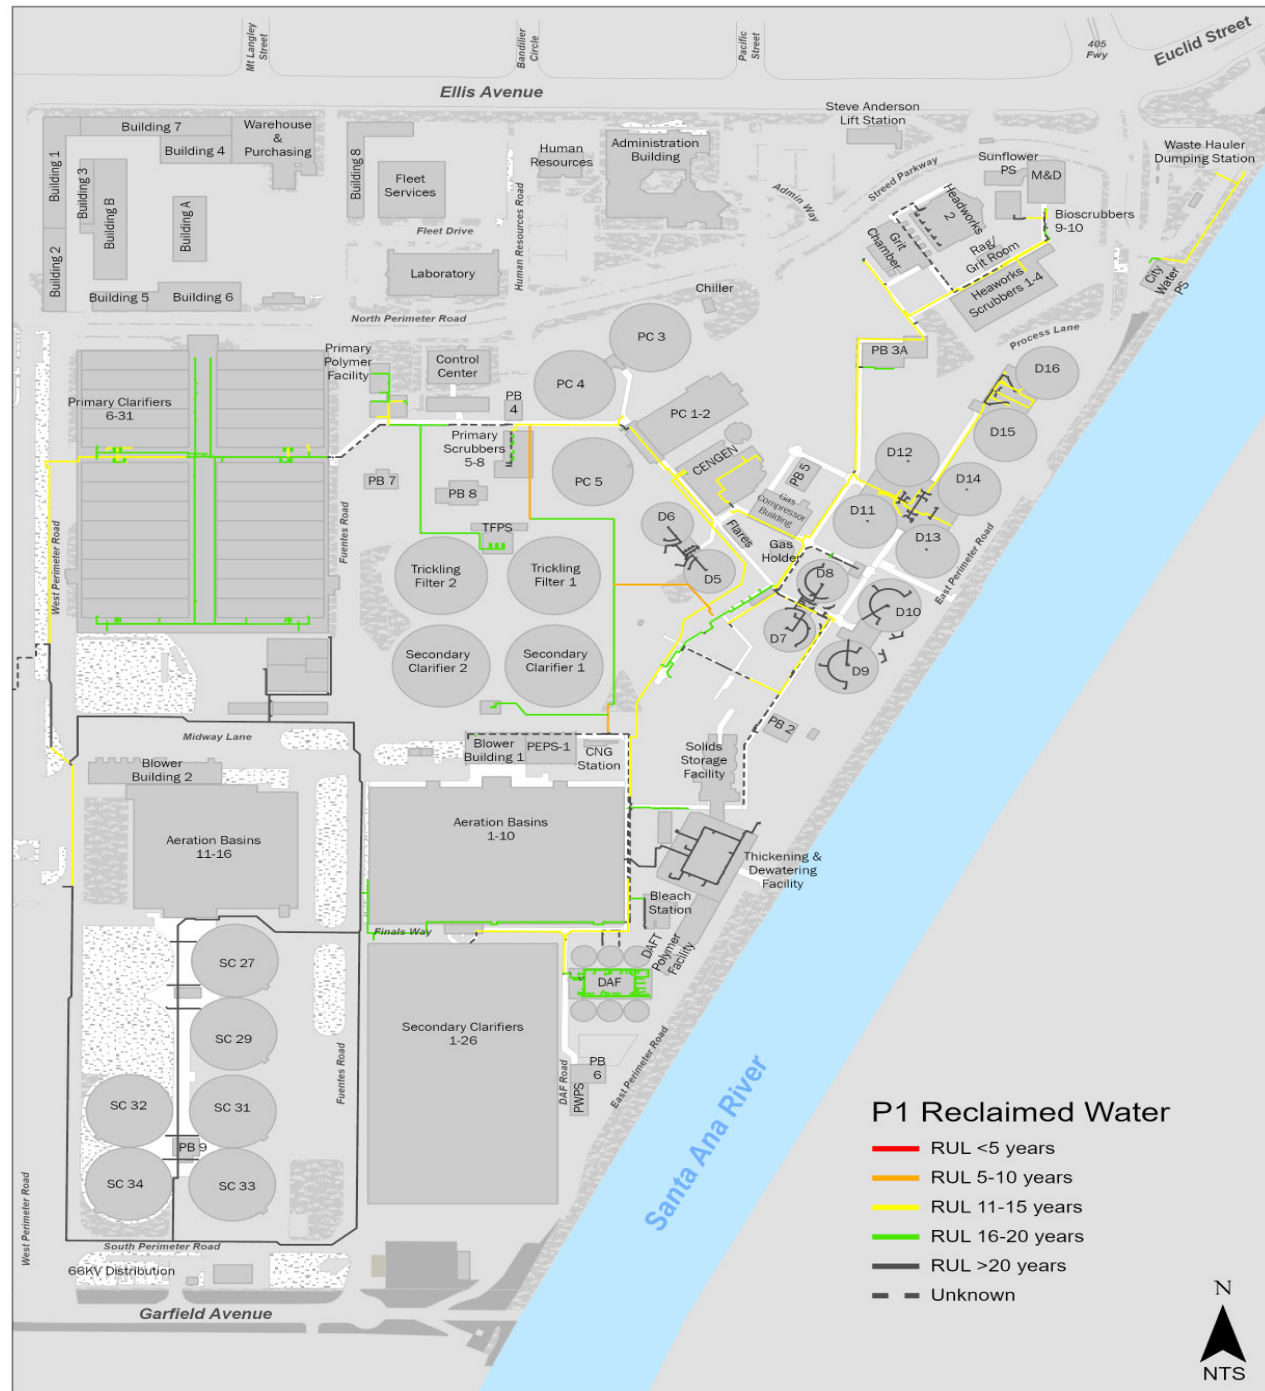
Remaining Useful Life of Utility Infrastructure

ASSET MANAGEMENT SYSTEM SUMMARY – AREA 17 – PLANT NO. 1 UTILITIES

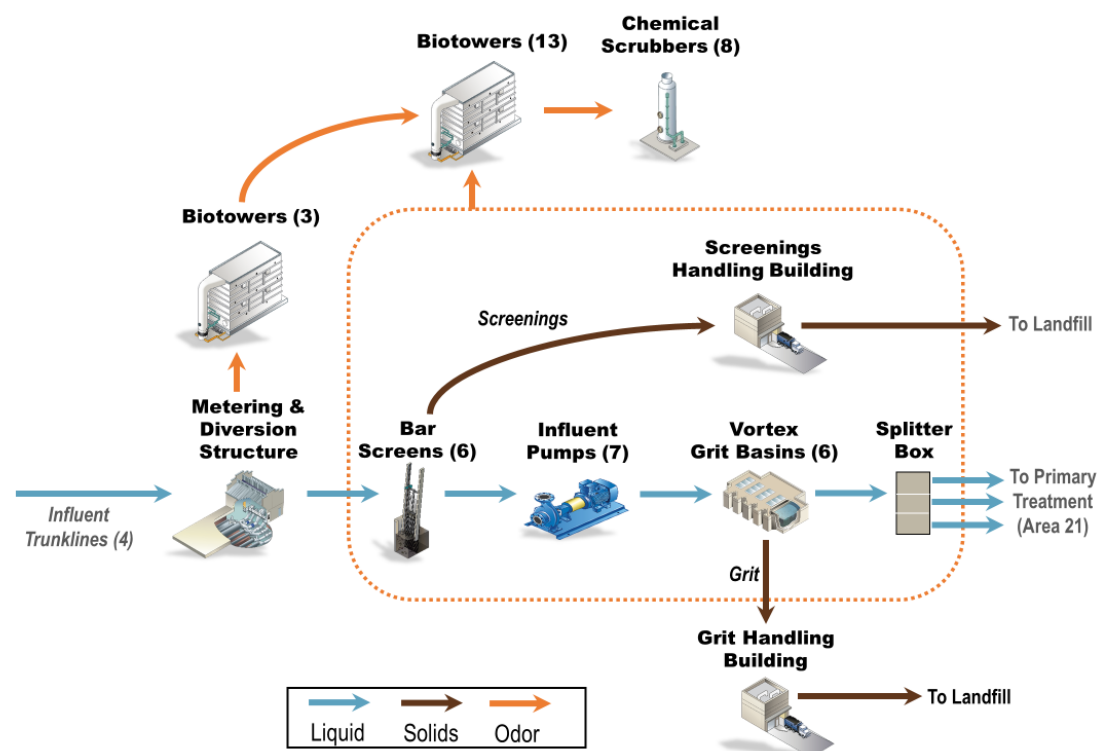
Note: Process Schematic is general in nature. A detailed process diagram is provided in Appendix D

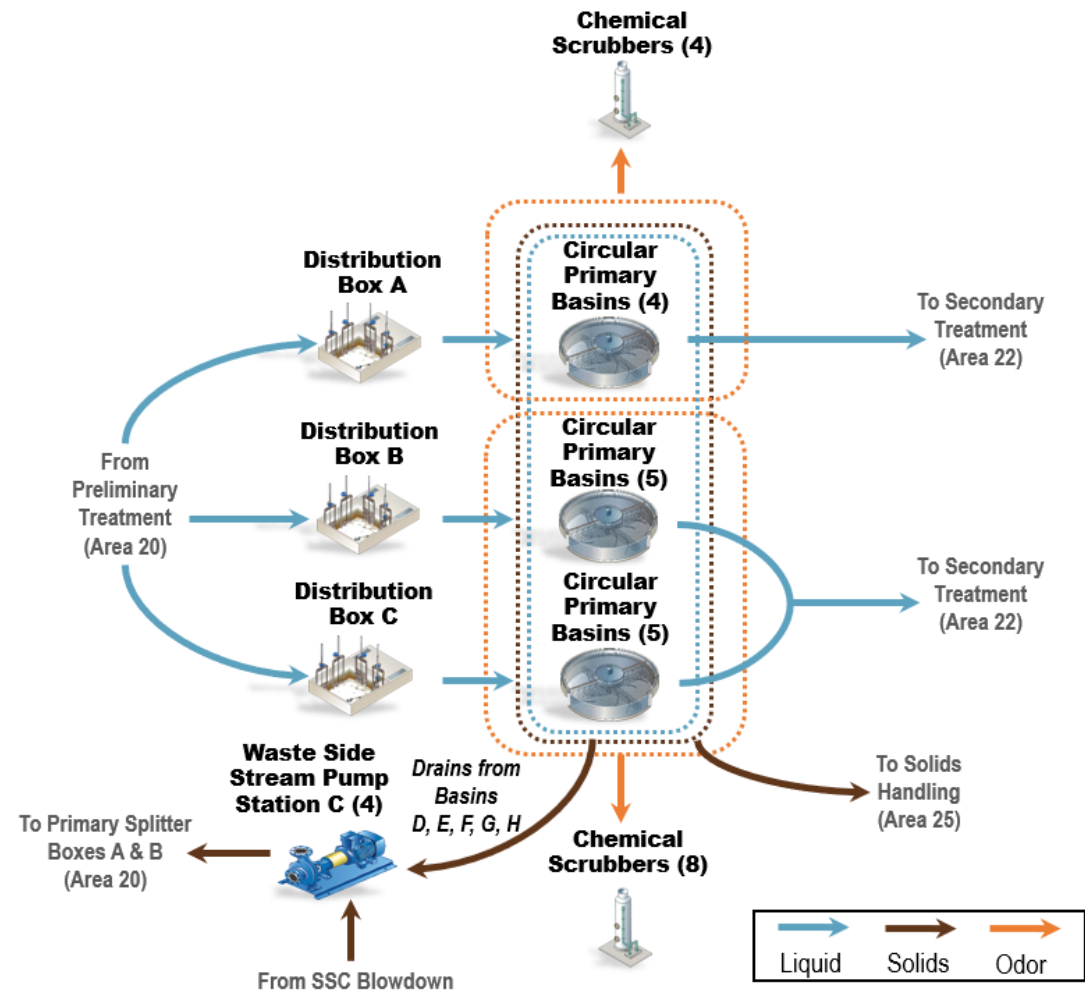
ASSET MANAGEMENT SYSTEM SUMMARY – AREA 21 – PLANT NO. 2 PRIMARY TREATMENT

Note: Process Schematic is general in nature. A detailed process diagram is provided in Appendix D

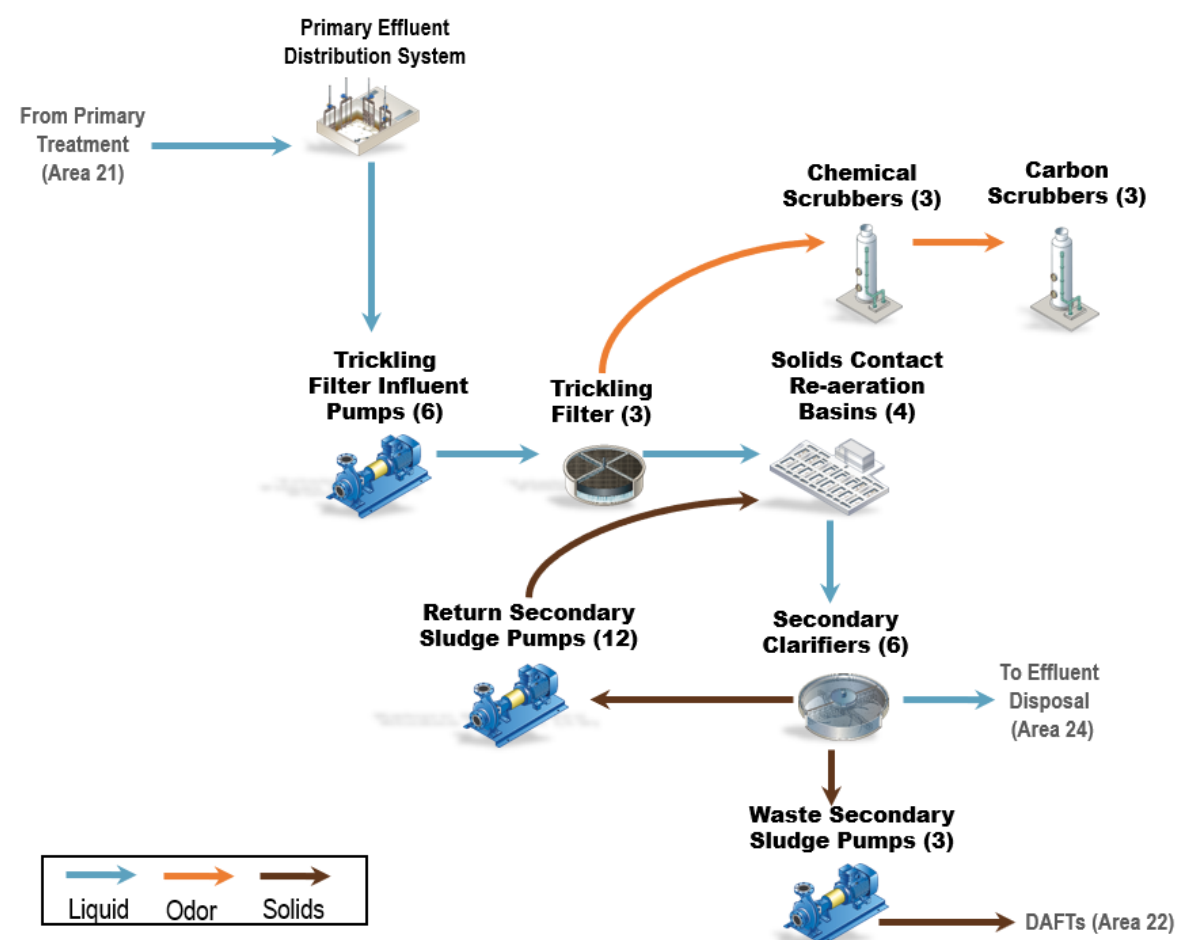
Process Schematic

ASSET MANAGEMENT SYSTEM SUMMARY – AREA 22 – PLANT NO. 2 SECONDARY TREATMENT – TRICKLING FILTERS AND SOLIDS CONTACT

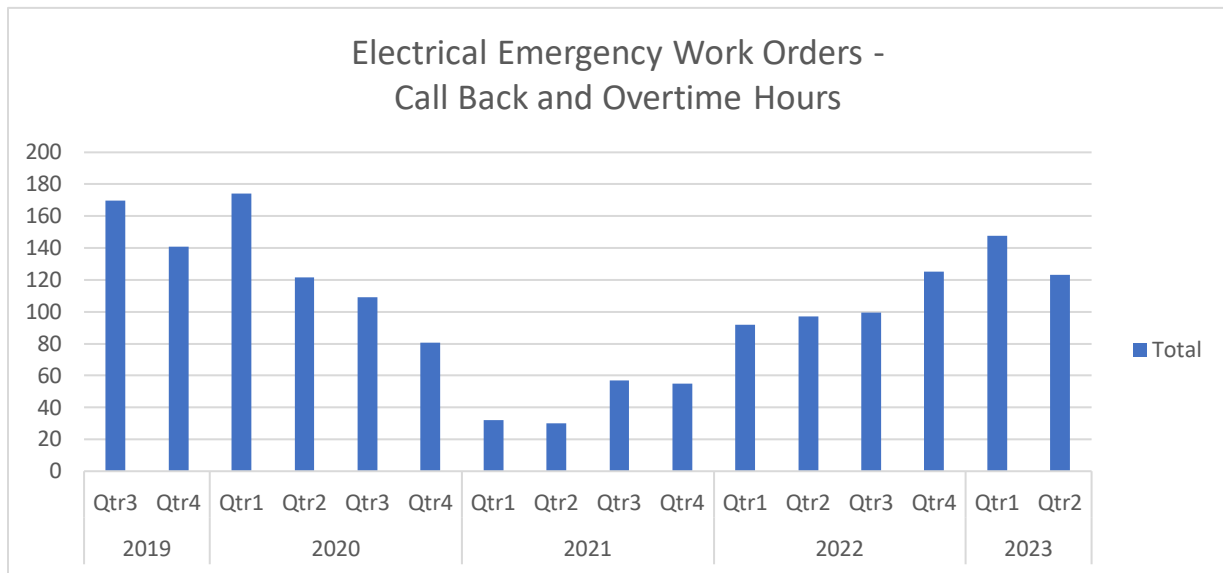
Figure 3-1. Electrical Emergency Work Orders

The trend in emergency call-out work for electrical and mechanical assets is shown on Figures 3-1 and 3-2, respectively, and reflects the demand older assets can have on maintaining the reliability of a facility.

The number of electrical “emergency” work orders and associated hours increased primarily due to electrical outages at the pump stations, and headworks power failure at both plants. There were also a few electrical emergency call outs to support the rain events. The mechanical emergency work increased primarily due to Plant No. 1 headworks and primary treatment mechanical failures. On average, about 80% of emergency mechanical call backs were to support Plant No. 1. We expect the trend for electrical break-in/emergency work to trend down as more electrical projects are implemented to replace or upgrade aging assets (for example, P1-105).

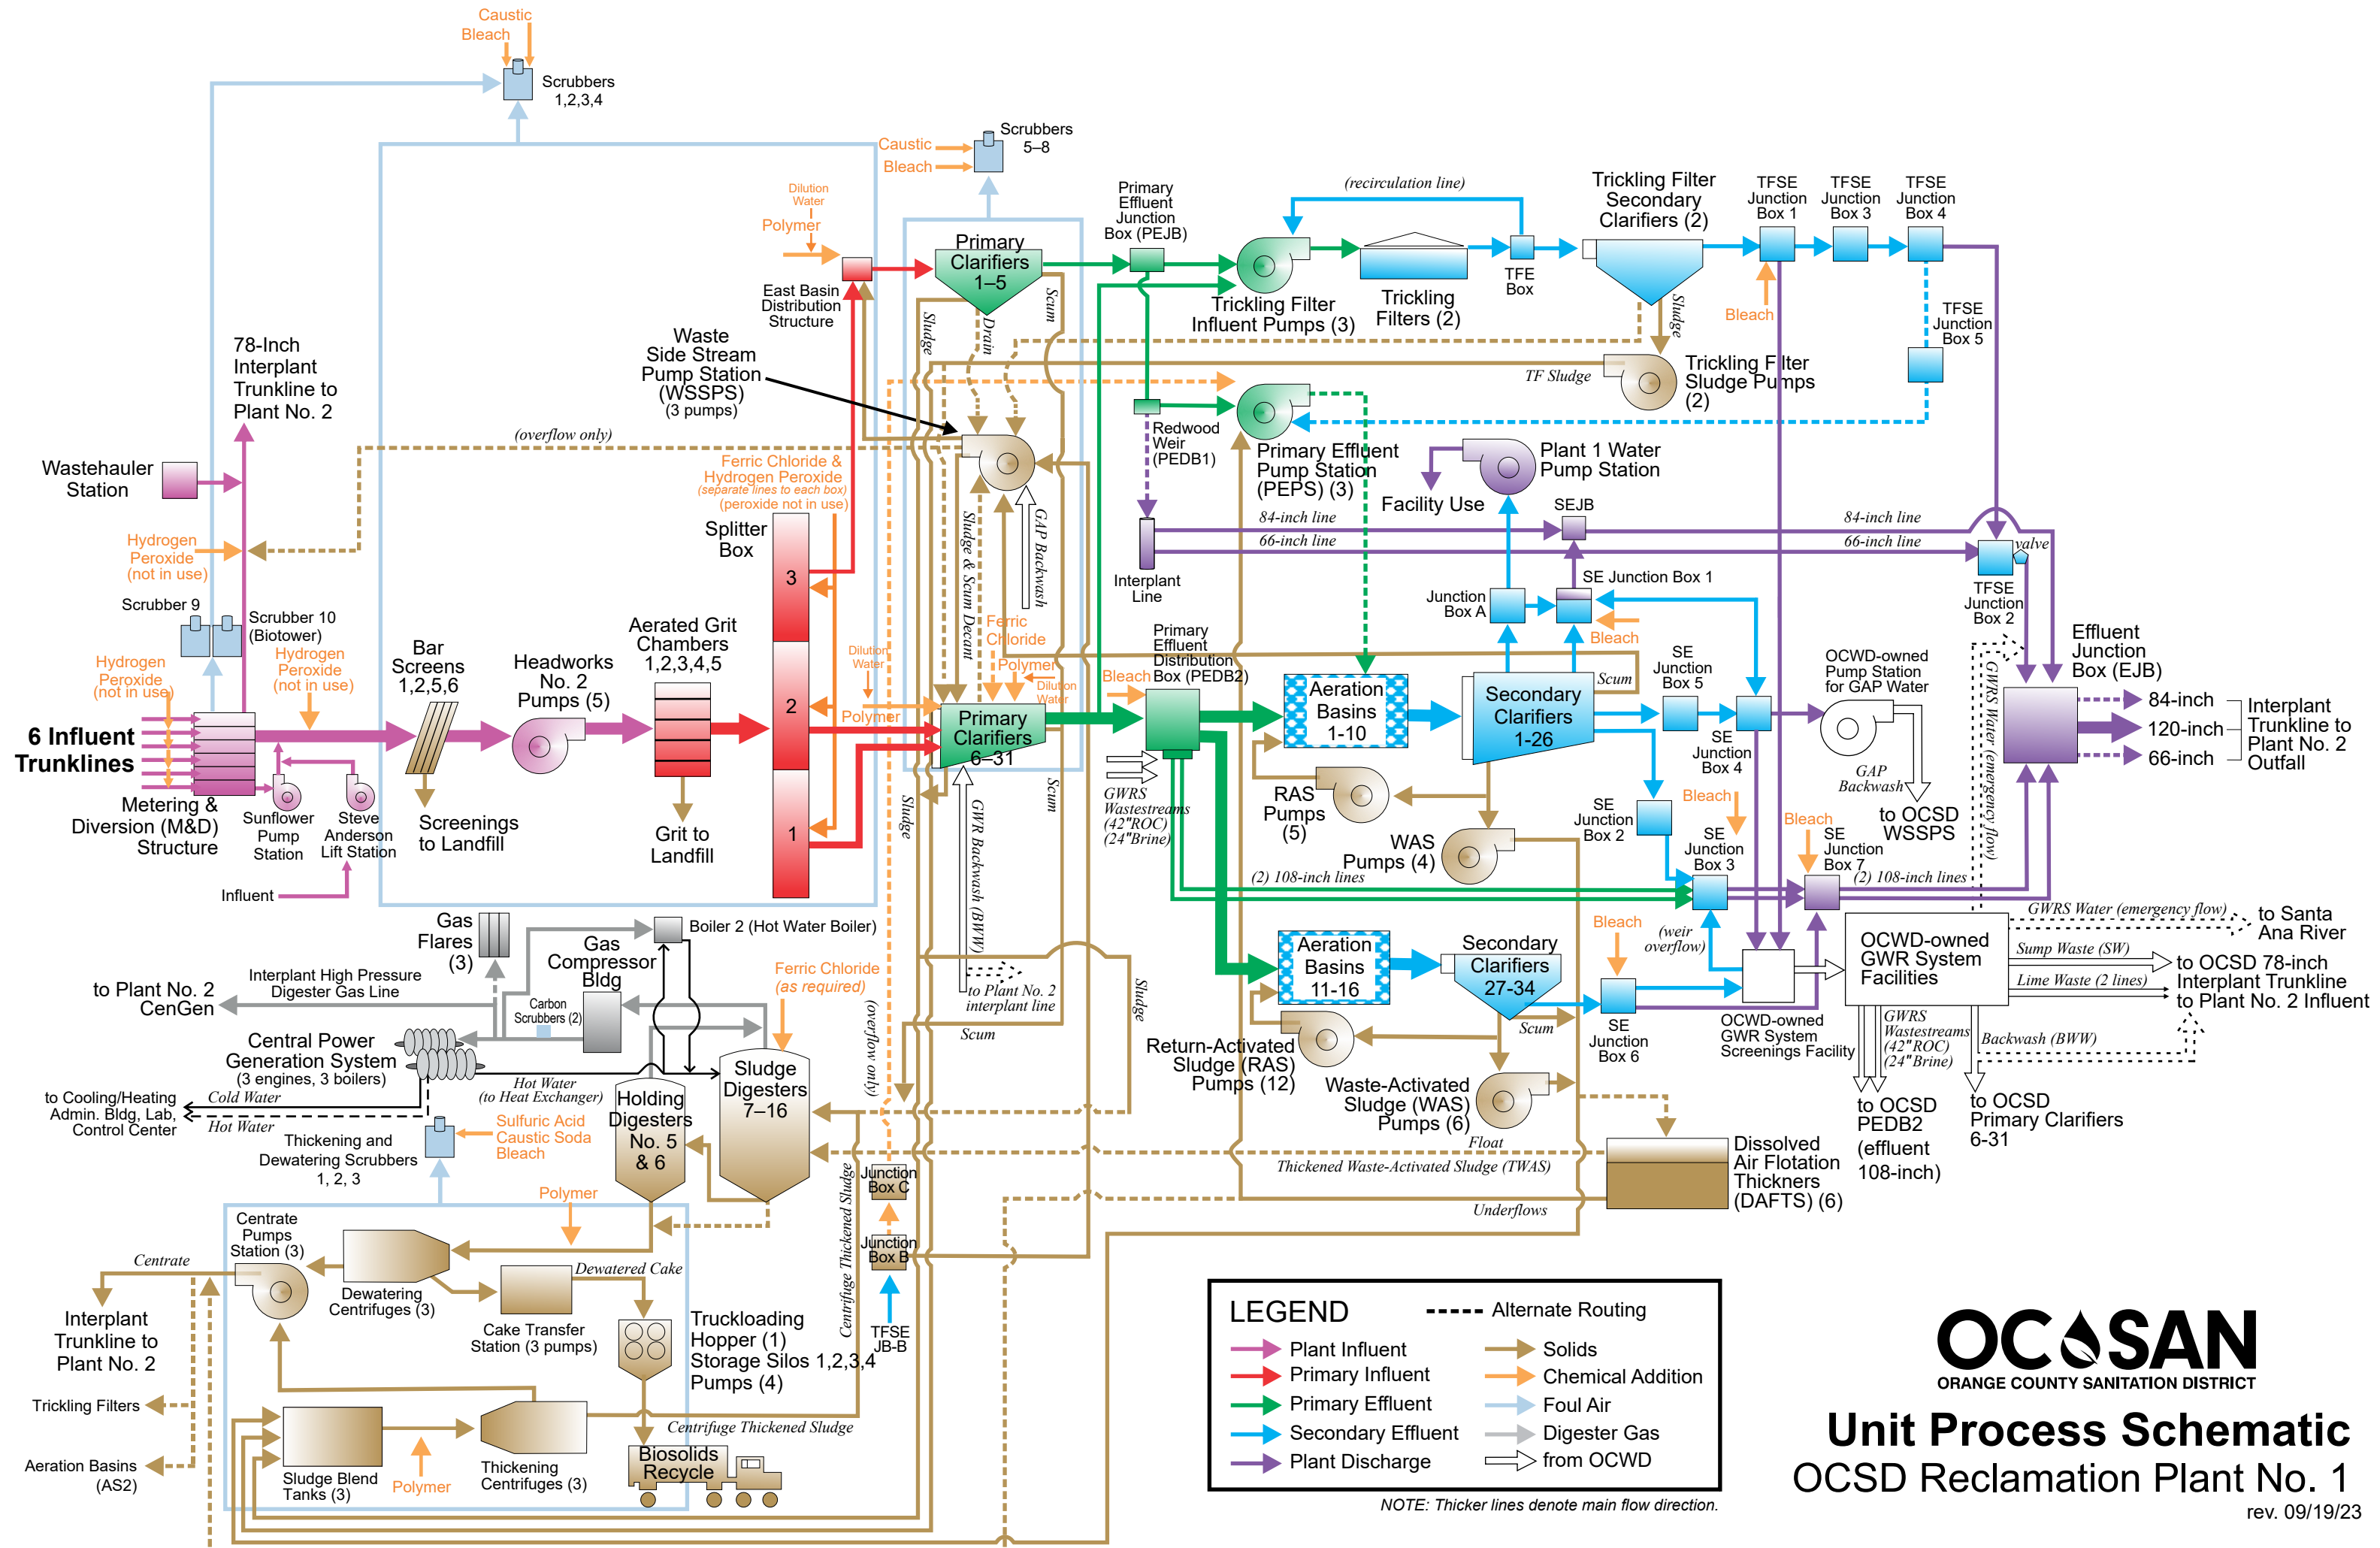
Appendix B
Plant No. 1 Process Diagram

- Plant Influent
- Primary Influent
- Primary Effluent
- Secondary Effluent
- Plant Discharge
- Alternate Routing
- Solids
- Chemical Addition
- Foul Air
- Digester Gas
- from OCWD
